Observations and measures

Faulty equipment

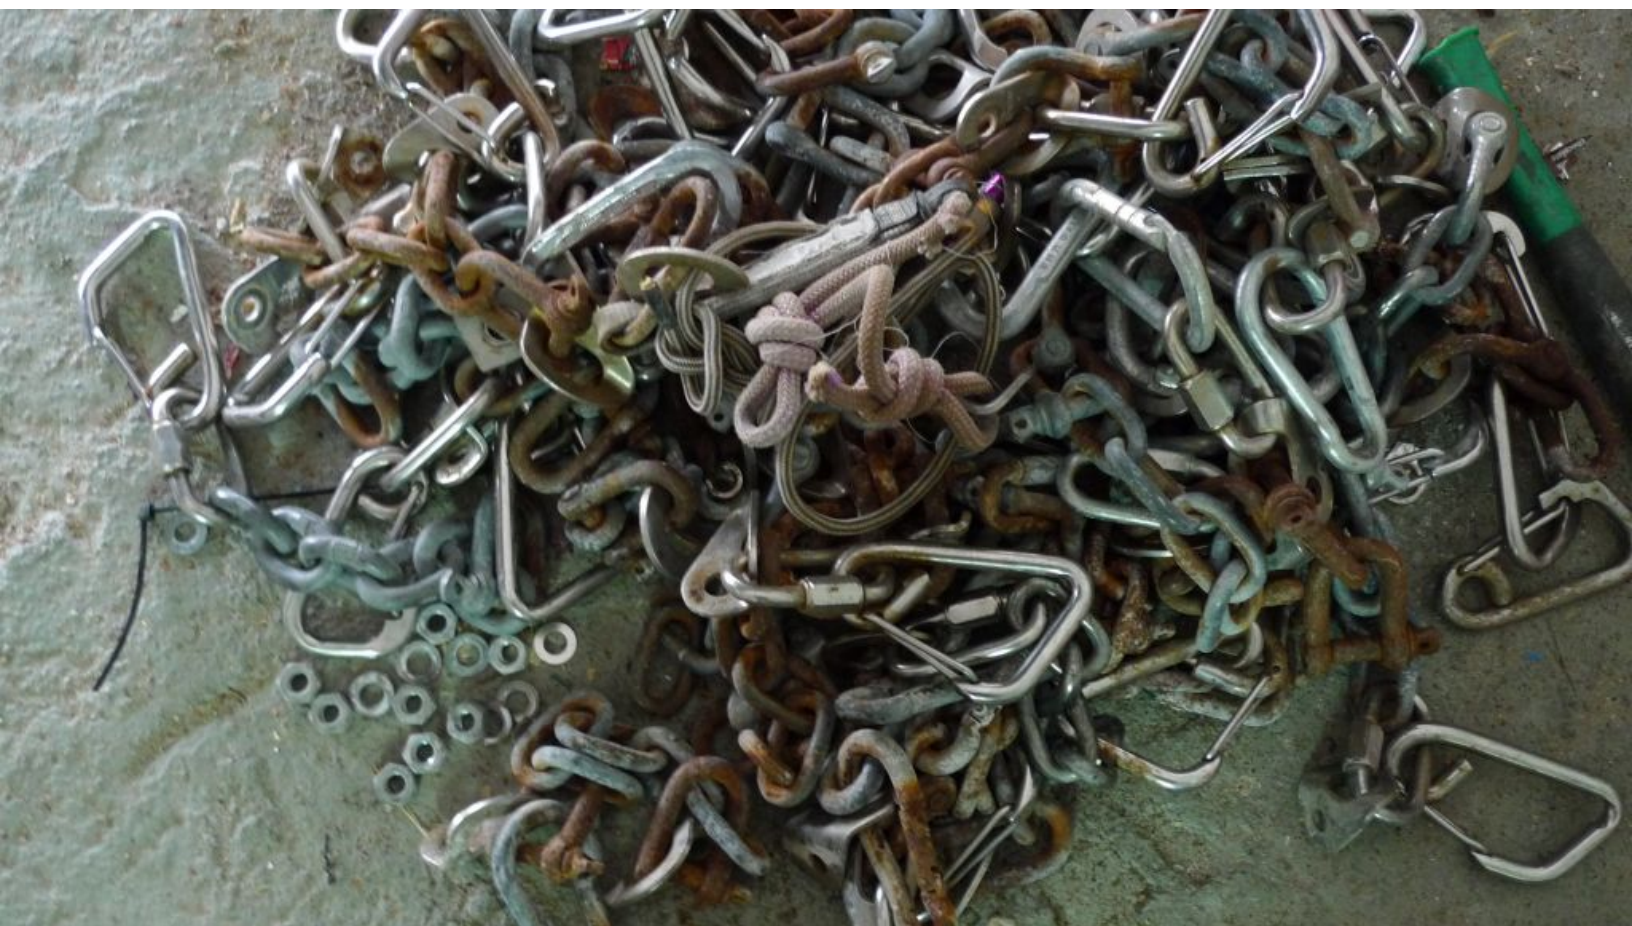
A. Theodoropoulos_Matériel usagé, Kalymnos, Grèce

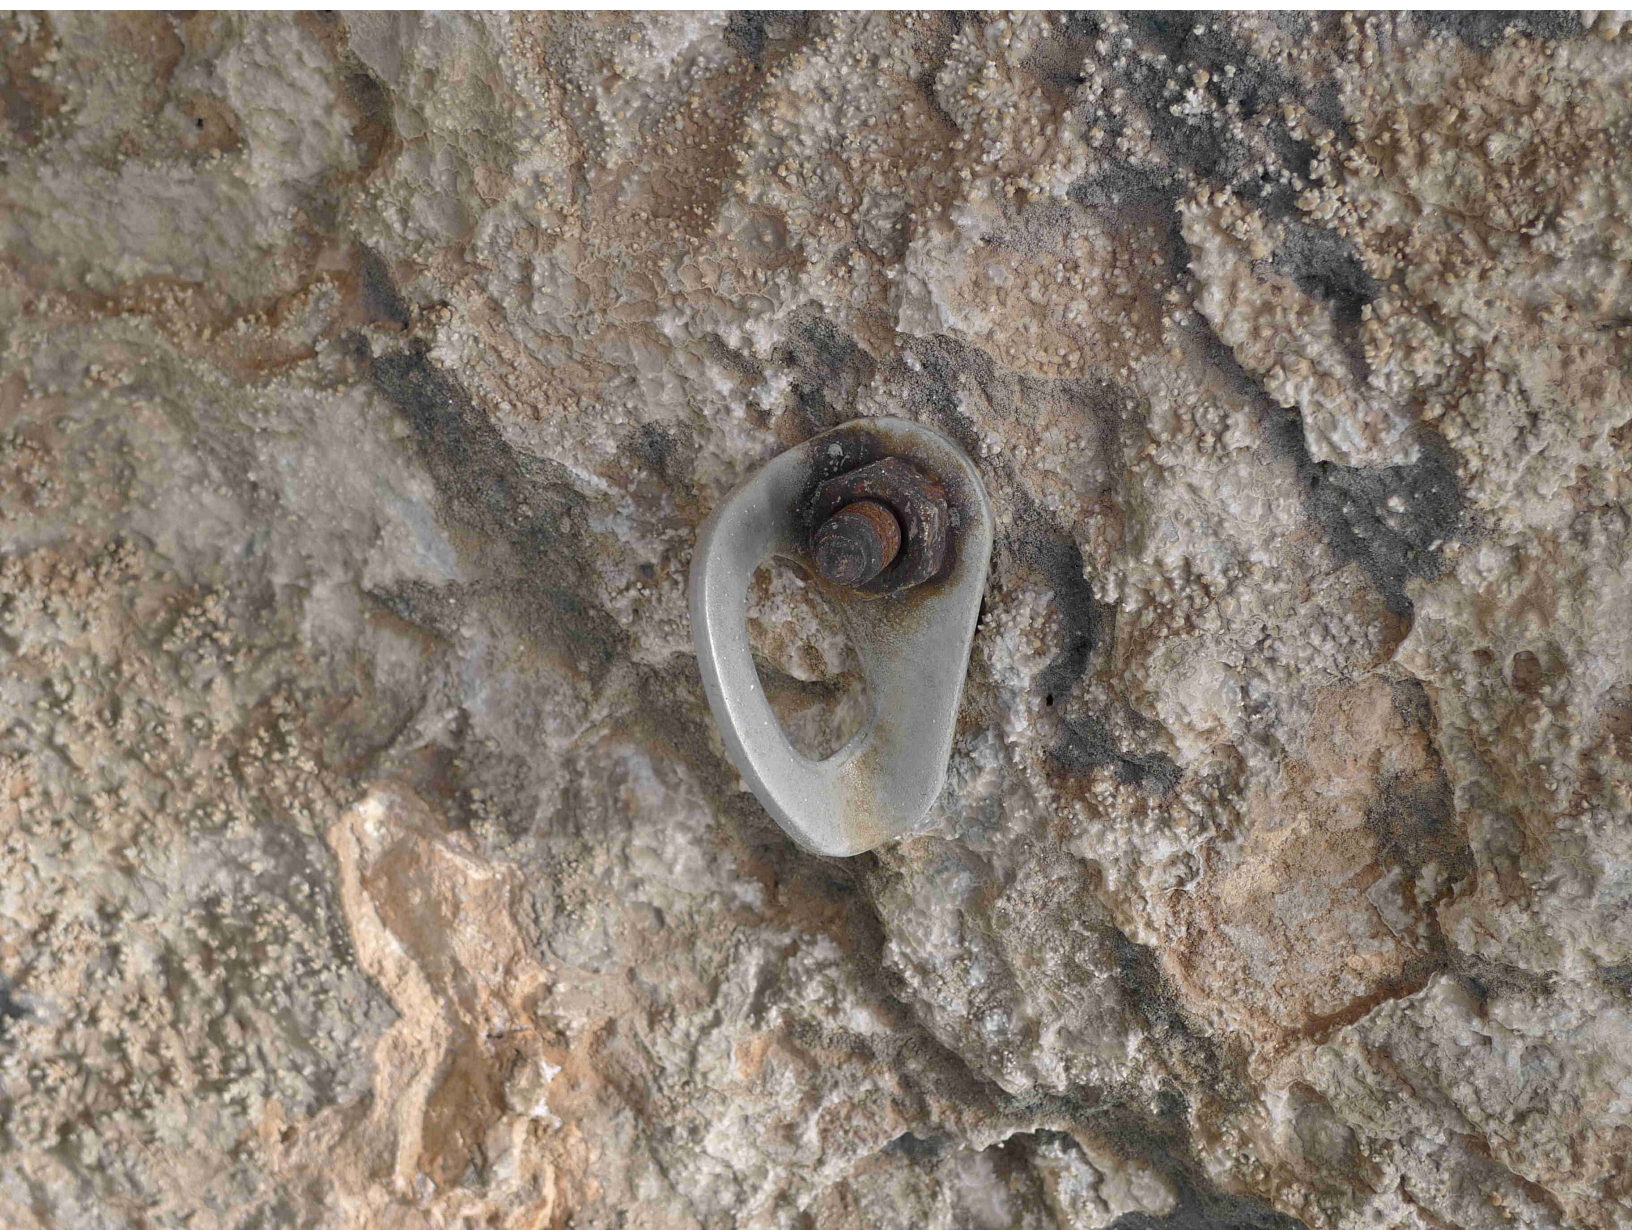
A. Theodoropoulos :Tampon dangereux, en très mauvais état, Kalymnos, Grèce

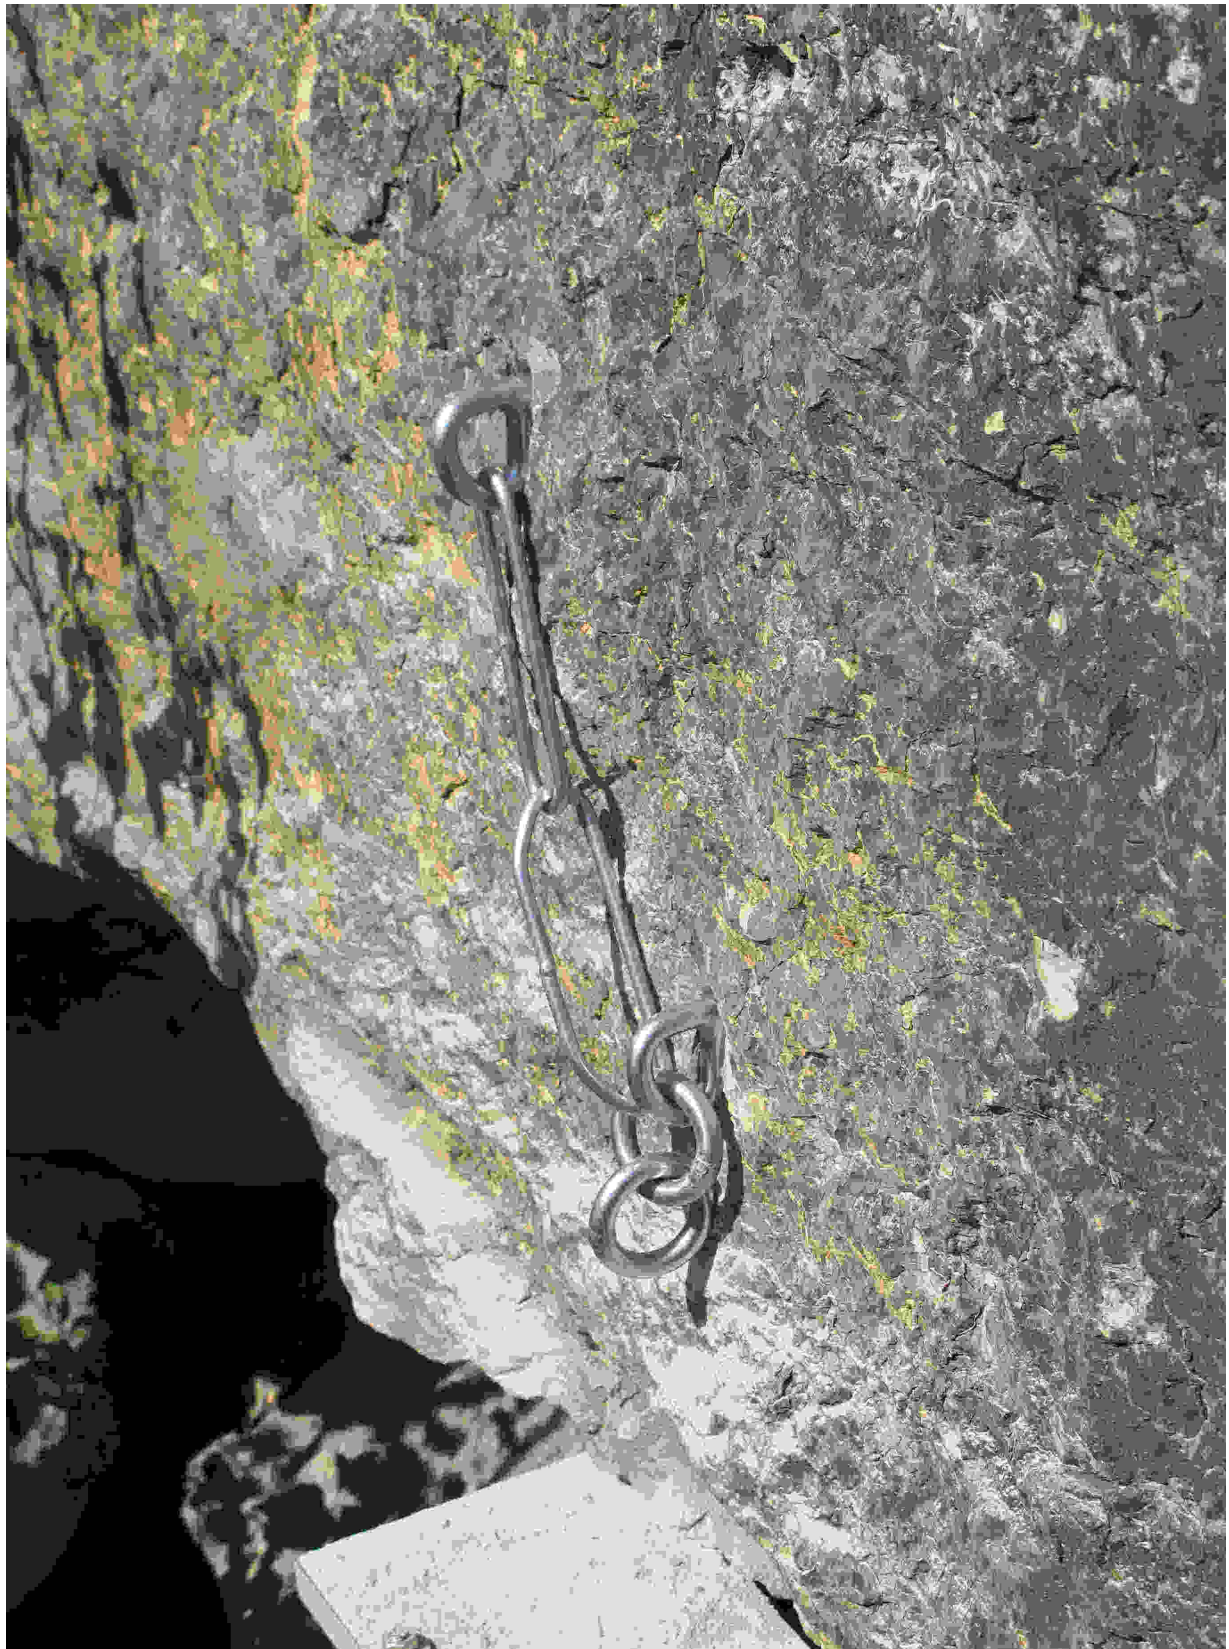
Chaîne et plaque inox A4 316L et boucles non A4

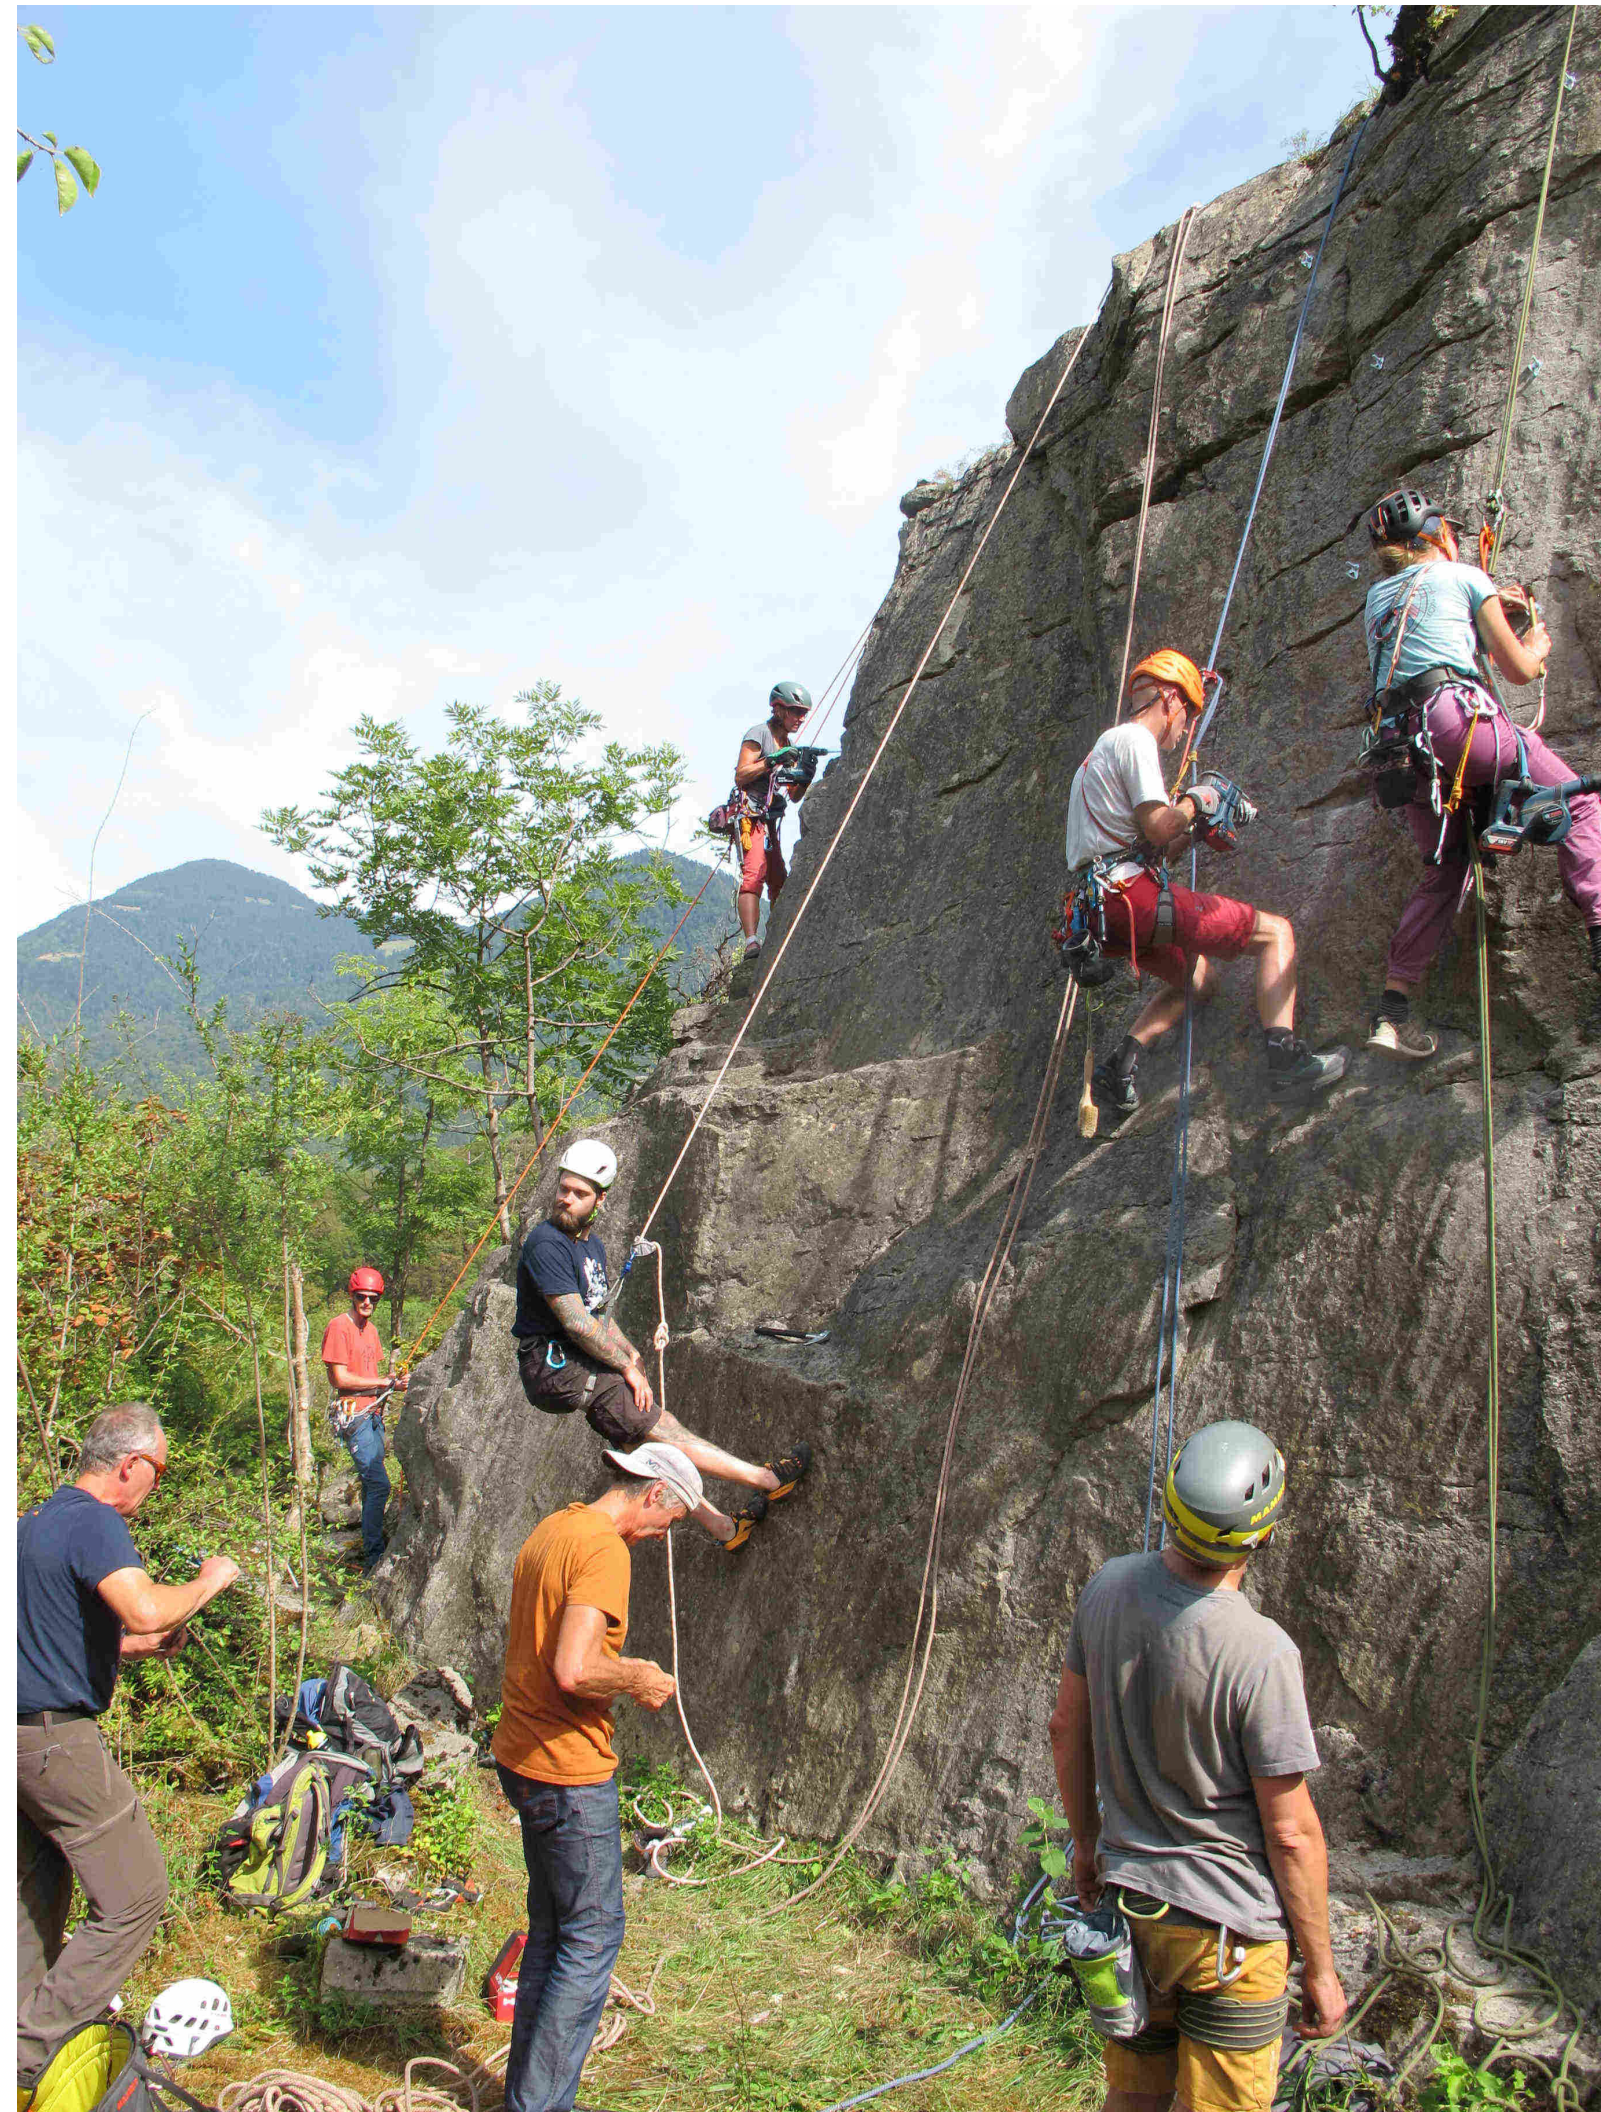
Différentes pièces endommagées par le temps et l'écrasement

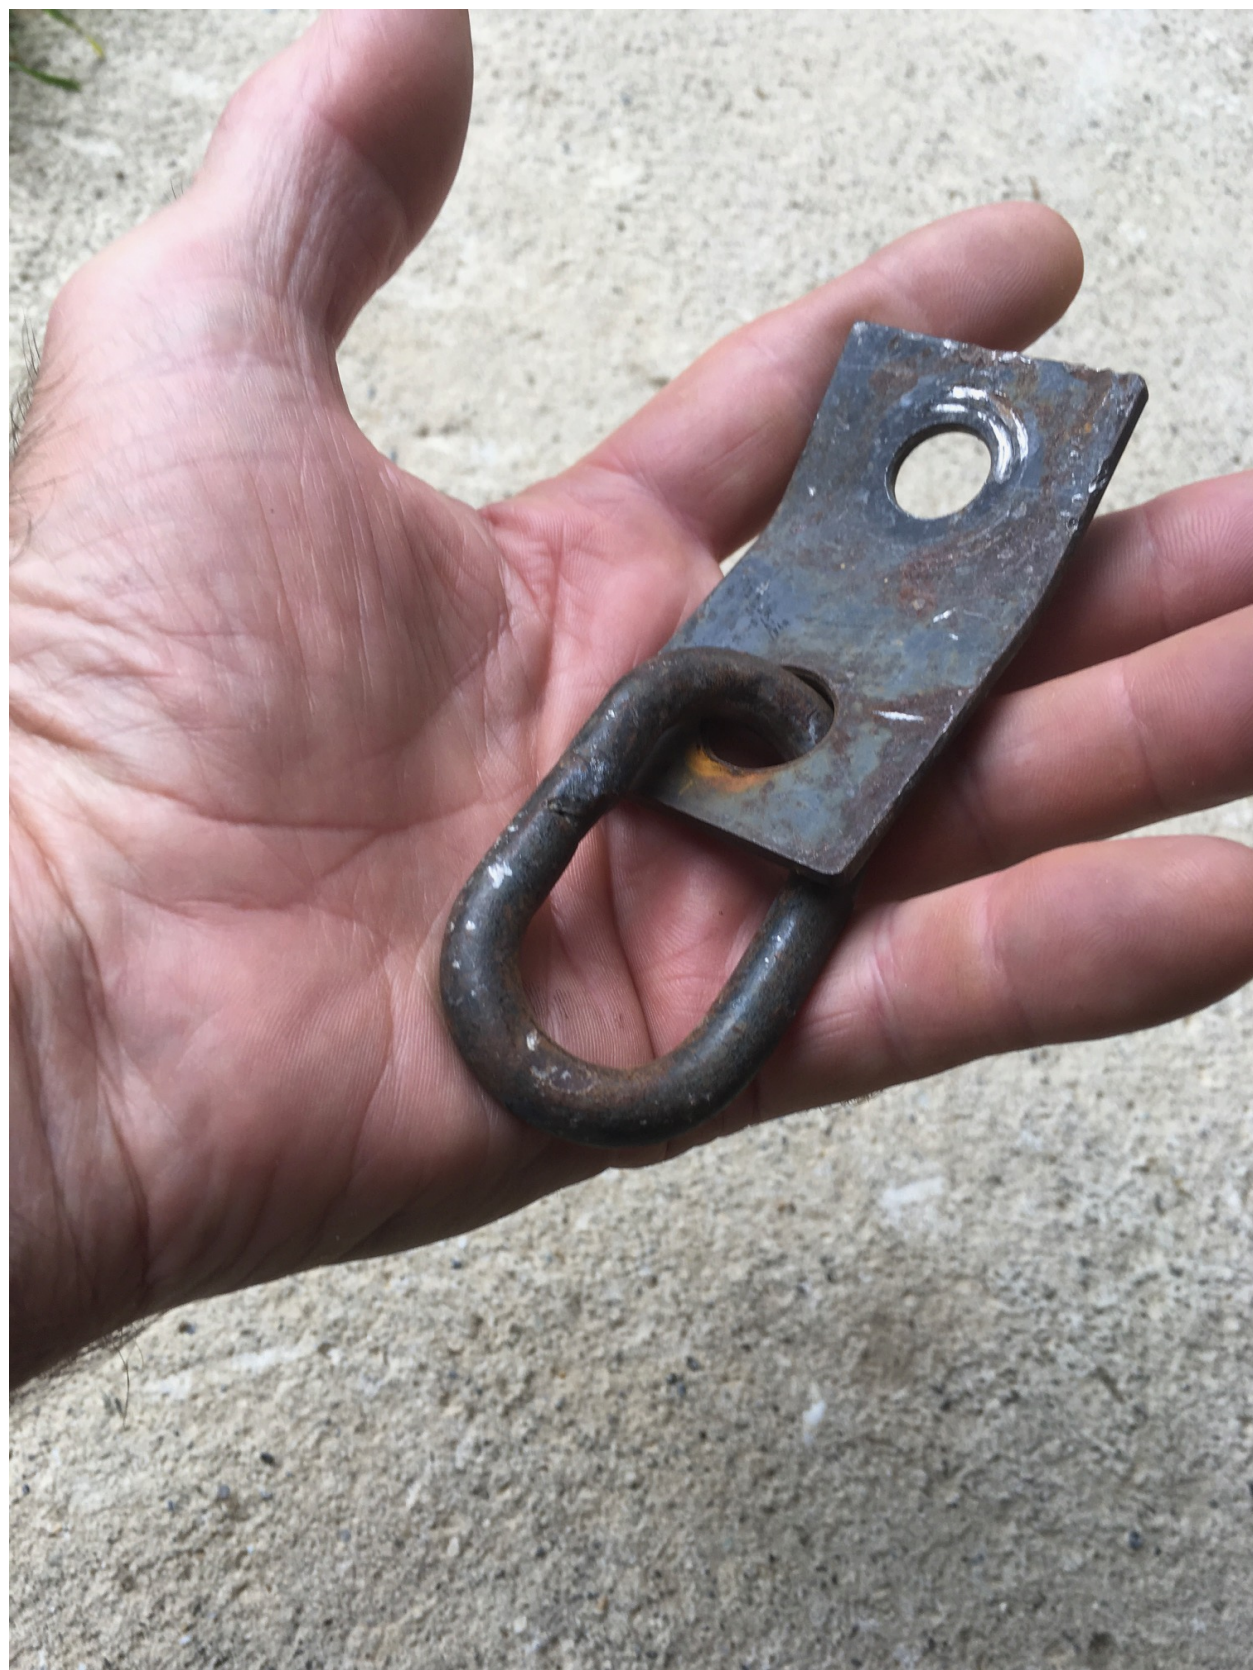
Plaquette à boucle artisanale restée plus de 30 ans en paroi, voie classique au Dar, Diablerets, Suisse

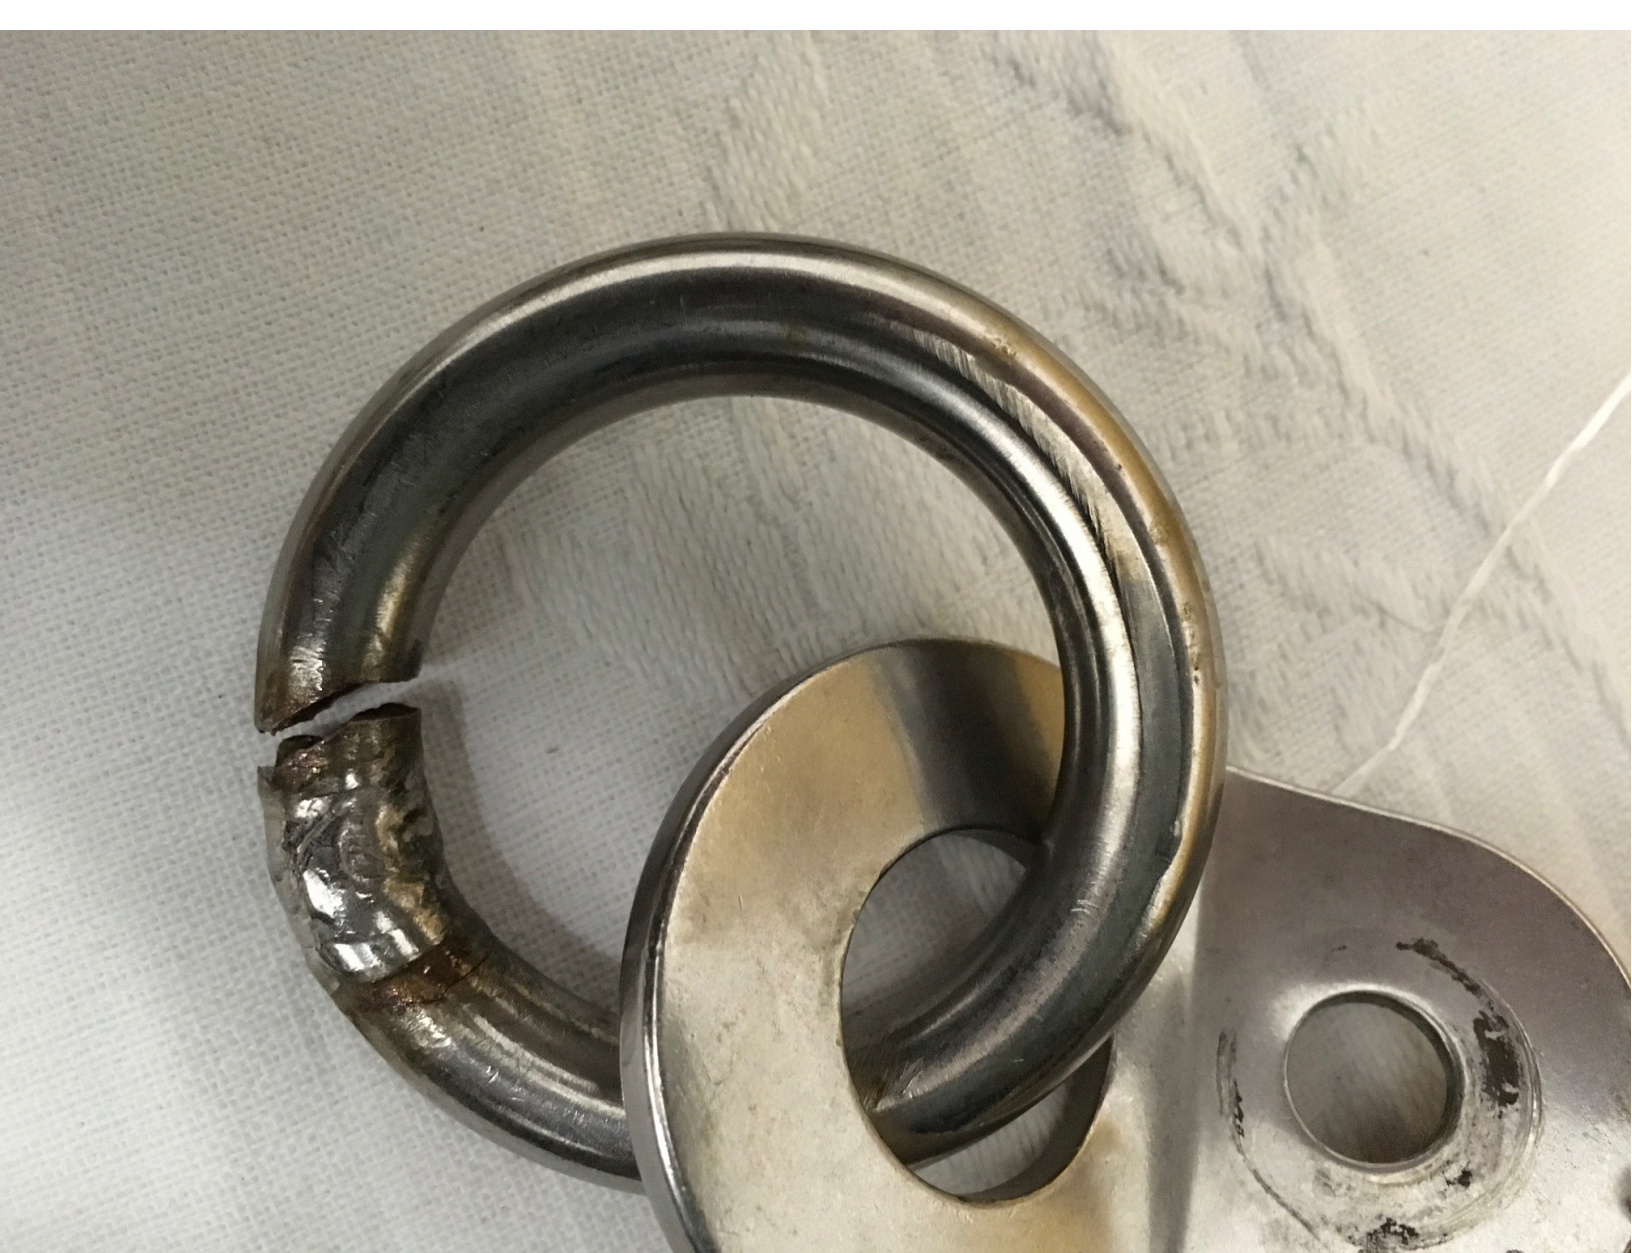
On February 23, 2024, a photo shows a split ring from a top anchor installed in 2022, from a new (Greek) manufacturer, in Leonidio, Greece... After on-the-spot verification, the municipality and the manufacturer were informed by the undersigned that ALL the rings of this brand observed in several sectors, even though they were recent, showed rust at the weld and that many were cracked or even split open! It should be pointed out that rings from other companies, not far from this area, were found to be faultless, even though they had been installed several years earlier. Shortly afterwards, the same defective equipment from this manufacturer was found in Kalymnos! At the beginning of April 2024, the manufacturer concerned by the rings came to Leonidio and made commitments (see below). Shortly afterwards, official analyses carried out by Professor Ulderico Santamaria, Director of the "Michele Cordaro" Laboratory of Diagnostics and Materials Science at Tuscia University in Viterbo, Italy, established that the welds, rings and hangers made by this manufacturer, who claims to meet UIAA standards for his equipment, were not of the advertised quality. It should be noted, however, that this manufacturer's

Plaquette et boucle A4 316L posée en 2022, boucle déjà fendue en 2024, Leonidio, Grèce

The manufacturer has promised the municipality of Leonidio and the undersigned that he will replace all his faulty equipment himself, as well as the equipment abroad, and will cover the shipping costs. Others, however, are slow to take a stand, or even fail to respond or even visit the sites. Any manufacturer concerned by proven defects in their products should come immediately to the site to recognize the problem, inform the people concerned and take charge of replacing defective or non-compliant parts, as all responsible companies do.

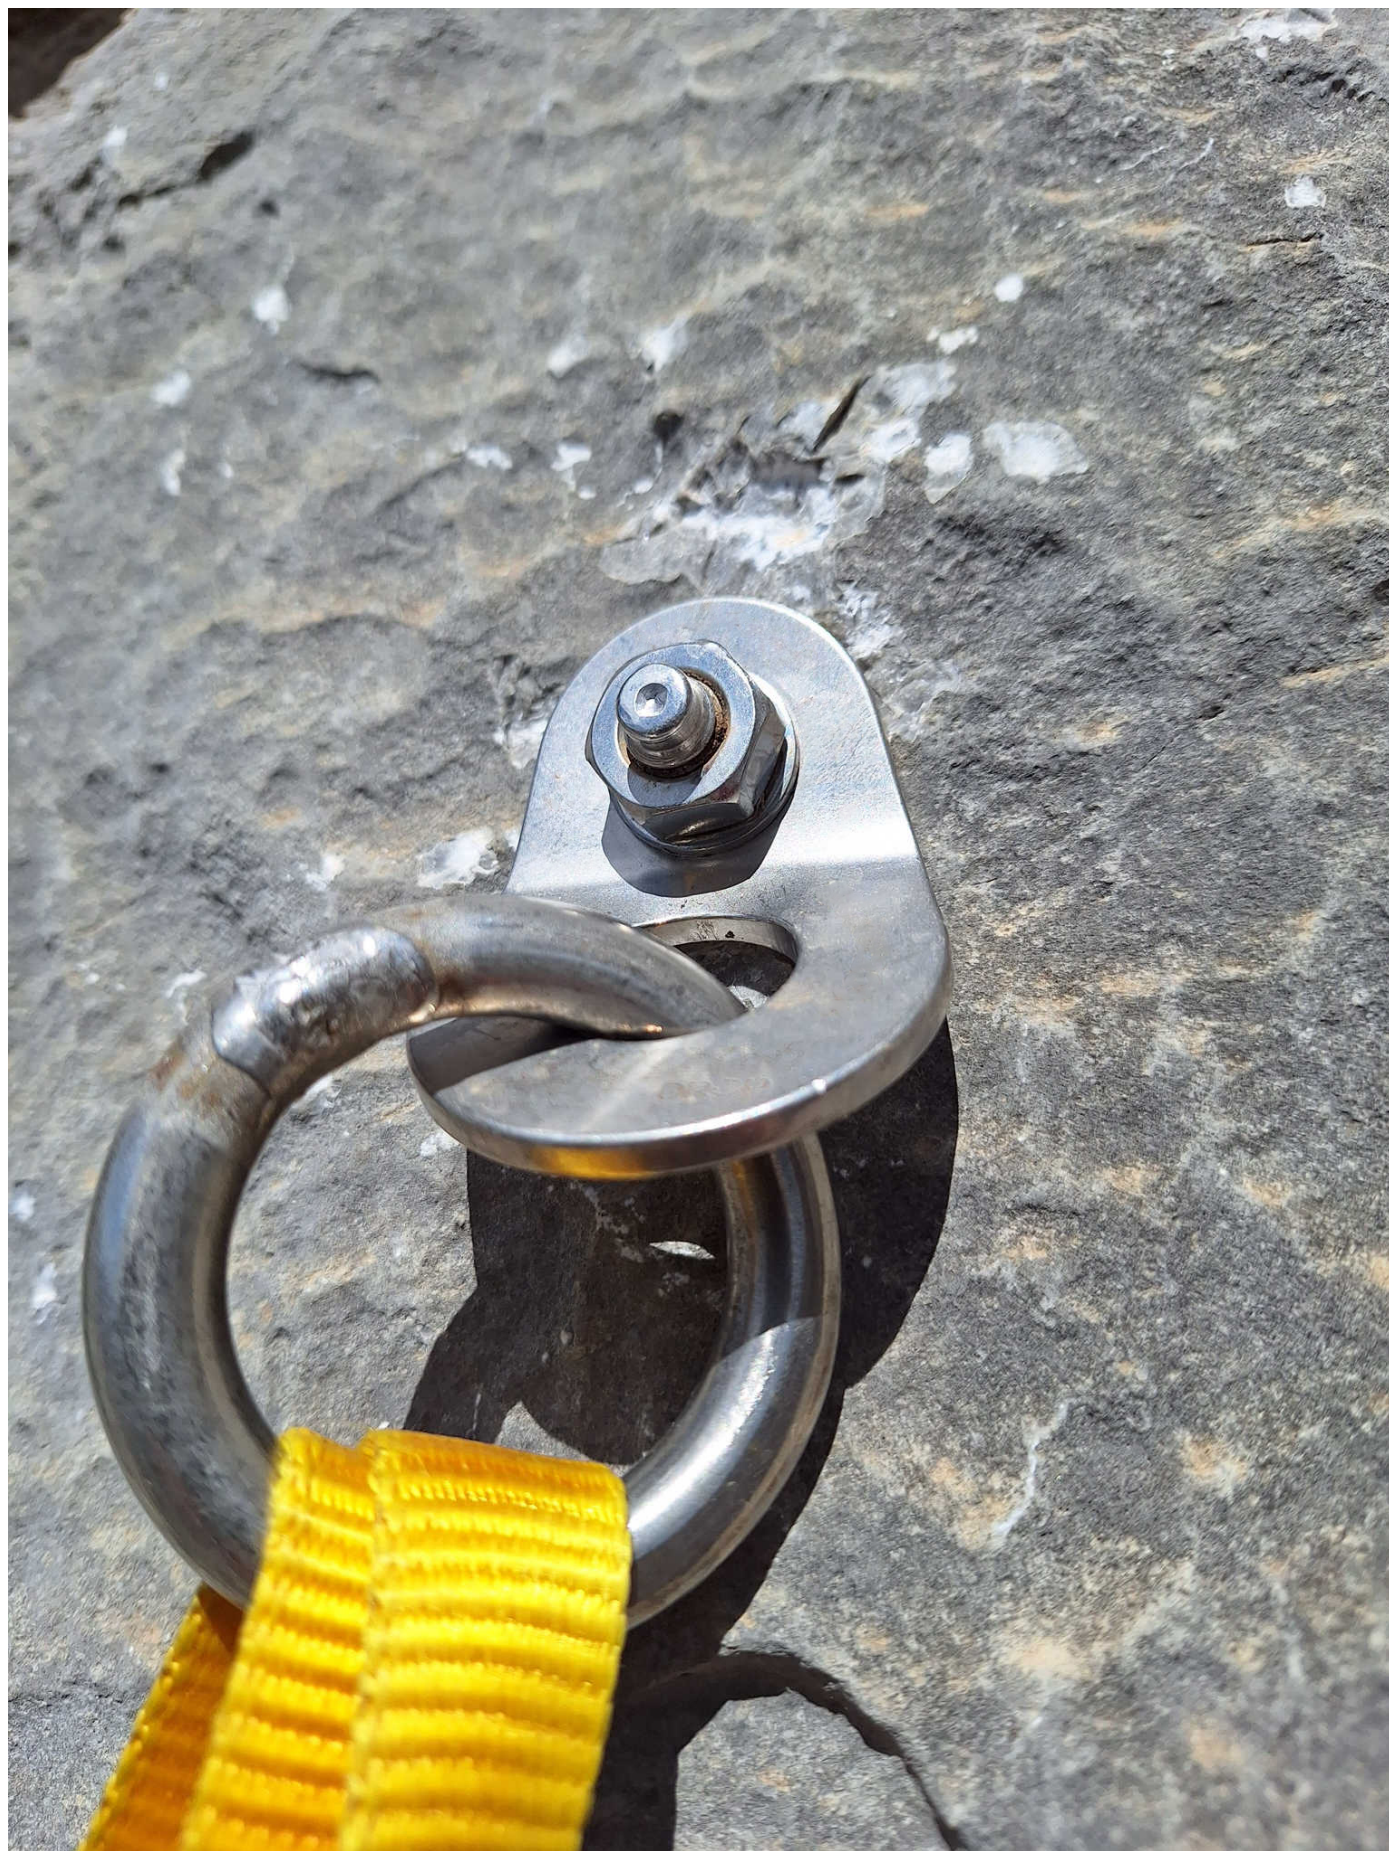
Plaquette et boucle A4 316L, posée en 2022, boucle déjà rouillée et fissurée en 2024, Leonidio, Grèce

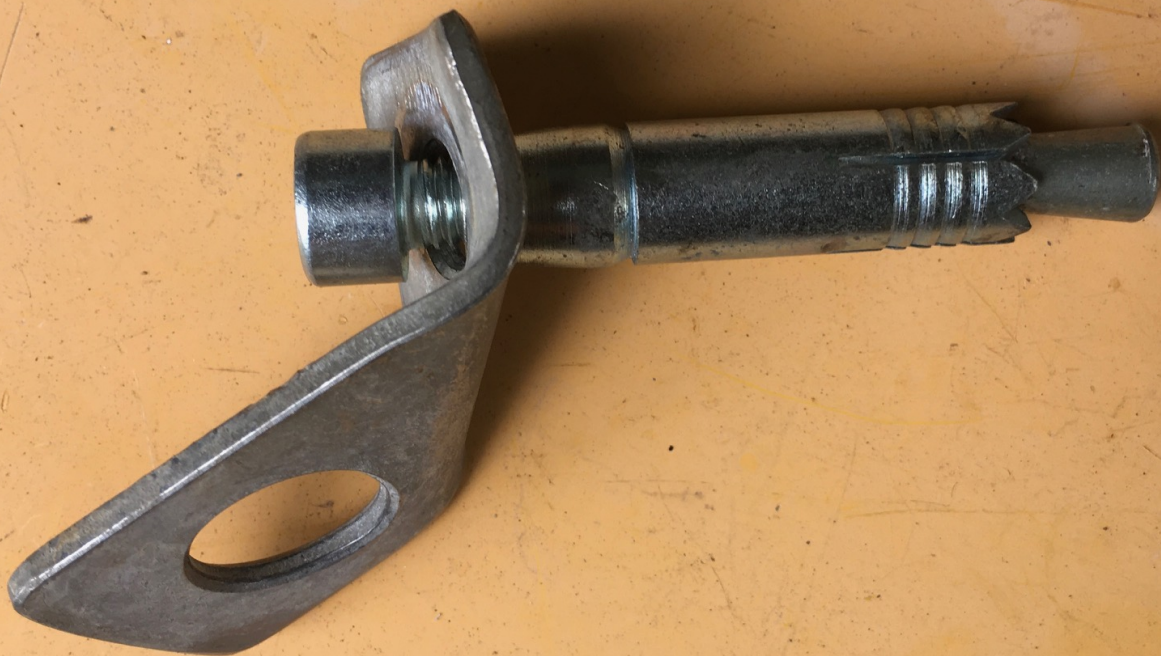
Shortly before 2008, the undersigned and a number of climbers in Kalymnos, Greece, noticed that anchors very occasionally broke. Autumn 2011, on the newly equipped Reize route at North Cape, a new anchor broke just as Renée Guerin, belayed by Bruno Fara, was pulling on a quickdraw. At the same time on the same island, on another new route, while an Englishman was taking a rest on an anchor, it broke, as did the next one in the ensuing fall! It then transpired that it was a former Greek manufacturer who had been supplying non-compliant equipment for two years to the new route setters on Kalymnos. Under an arrangement between the manufacturer and the local municipality, Aris Theodoropoulos and his friends replaced around 500 anchors.

Tampons cassés en 2010, Kalymnos, Grèce

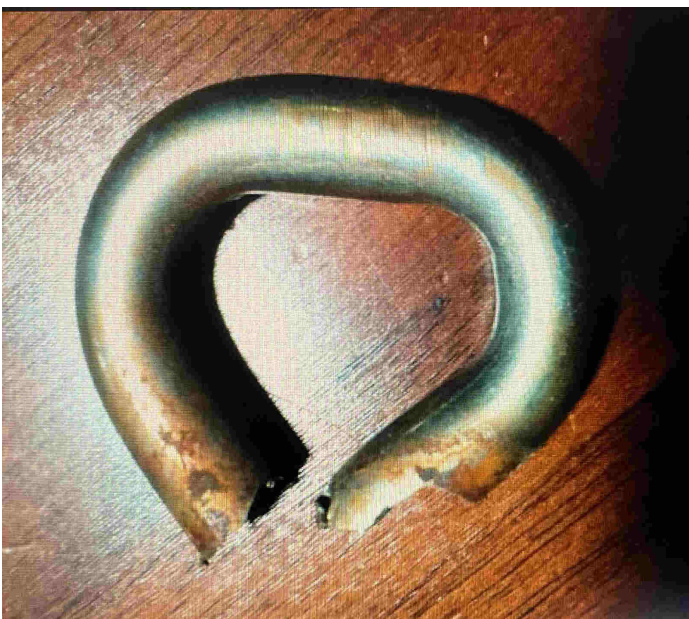
In 2011, the undersigned and other climbers noticed a recurring fault with a bolt from a well-known brand: around one in ten was turning in the void when being tightened. In 2014, on the seaside of the Sperlonga region of Italy, where the Grotta dell'Arenauta is located, Federico D'Isep, Enrico Mazzoli and other climbers also noticed, sometimes with quite a scare, that anchors and chains from well-known brands were breaking easily, as in Kalymnos! It took a while to explain the problem: it wasn't the sulphur or the sea air as first thought, but stainless steel equipment that wasn't of the

advertised quality. This was demonstrated by analyses carried out later, by the Laboratory of Diagnostics and Materials Science at Tuscia University in Viterbo, Italy, on broken material that had been preserved. Similar problems have been encountered with many seaside anchors in several countries. On the other hand, at San Vito lo Capo, Sicily, despite the presence of sulphur and sea spray from strong westerly winds, Daniele Arena, who closely monitors the corrosion of anchors, found no attack on the stainless steel installed in the 80s, nor on the 316L used for retrofitting.

F. D'Isep : Broche cassée, Italie

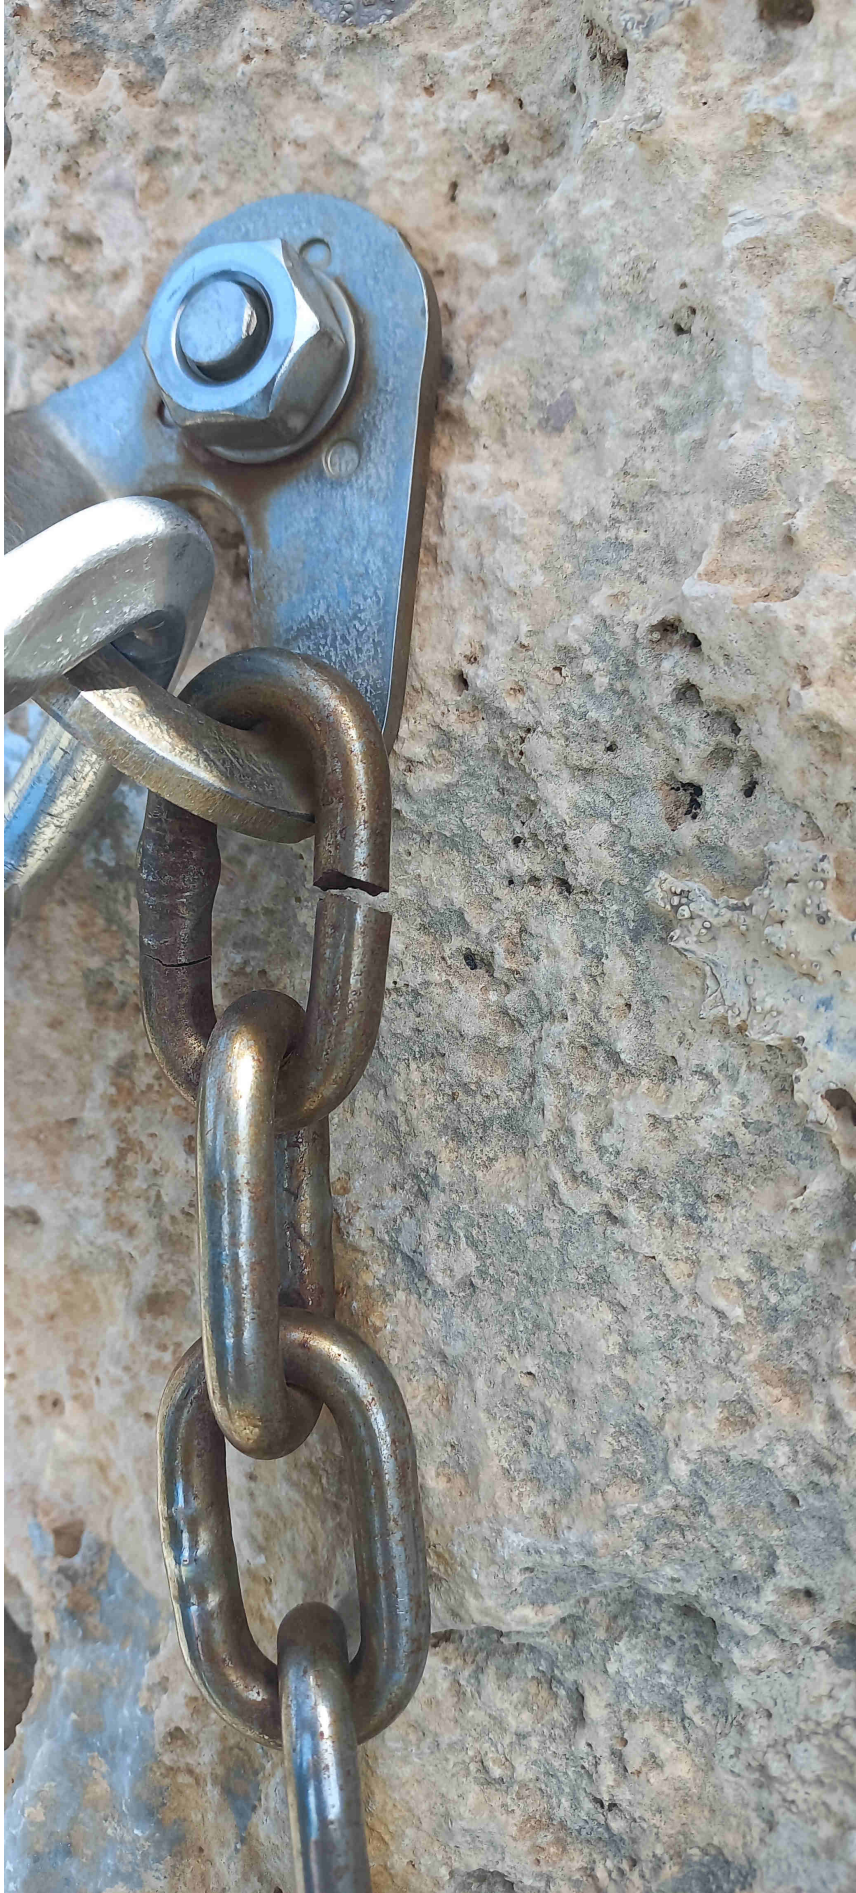
L. Salsotto : Chaîne fendue, Kalymnos, Grèce

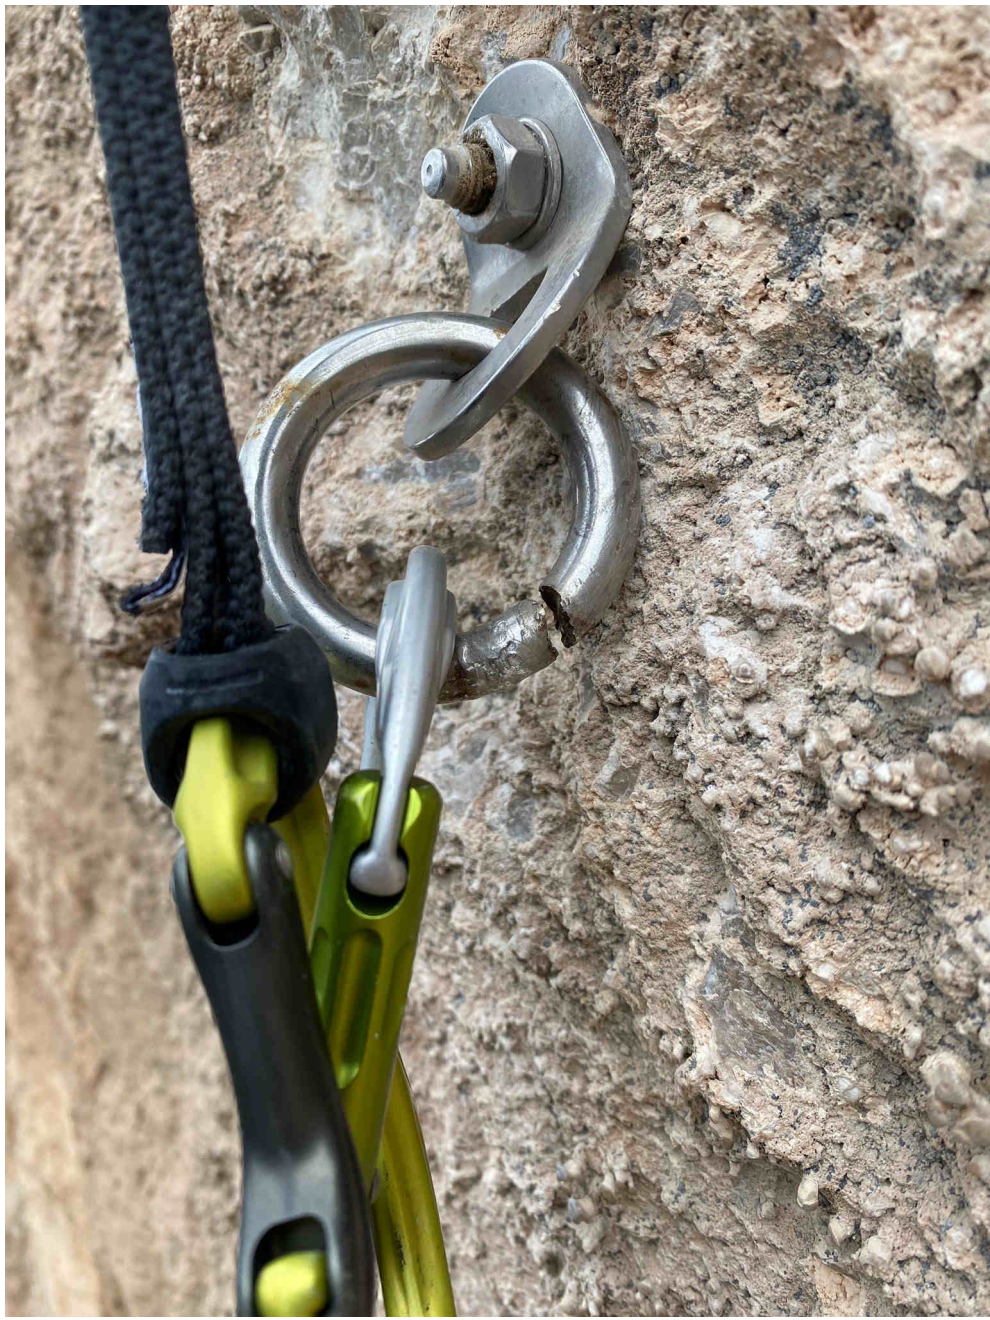
Municipalité Leonidio : Plaquette et boucle A4 316L posée en 2022, boucle déjà fendue en 2024, Leonidio, Grèce

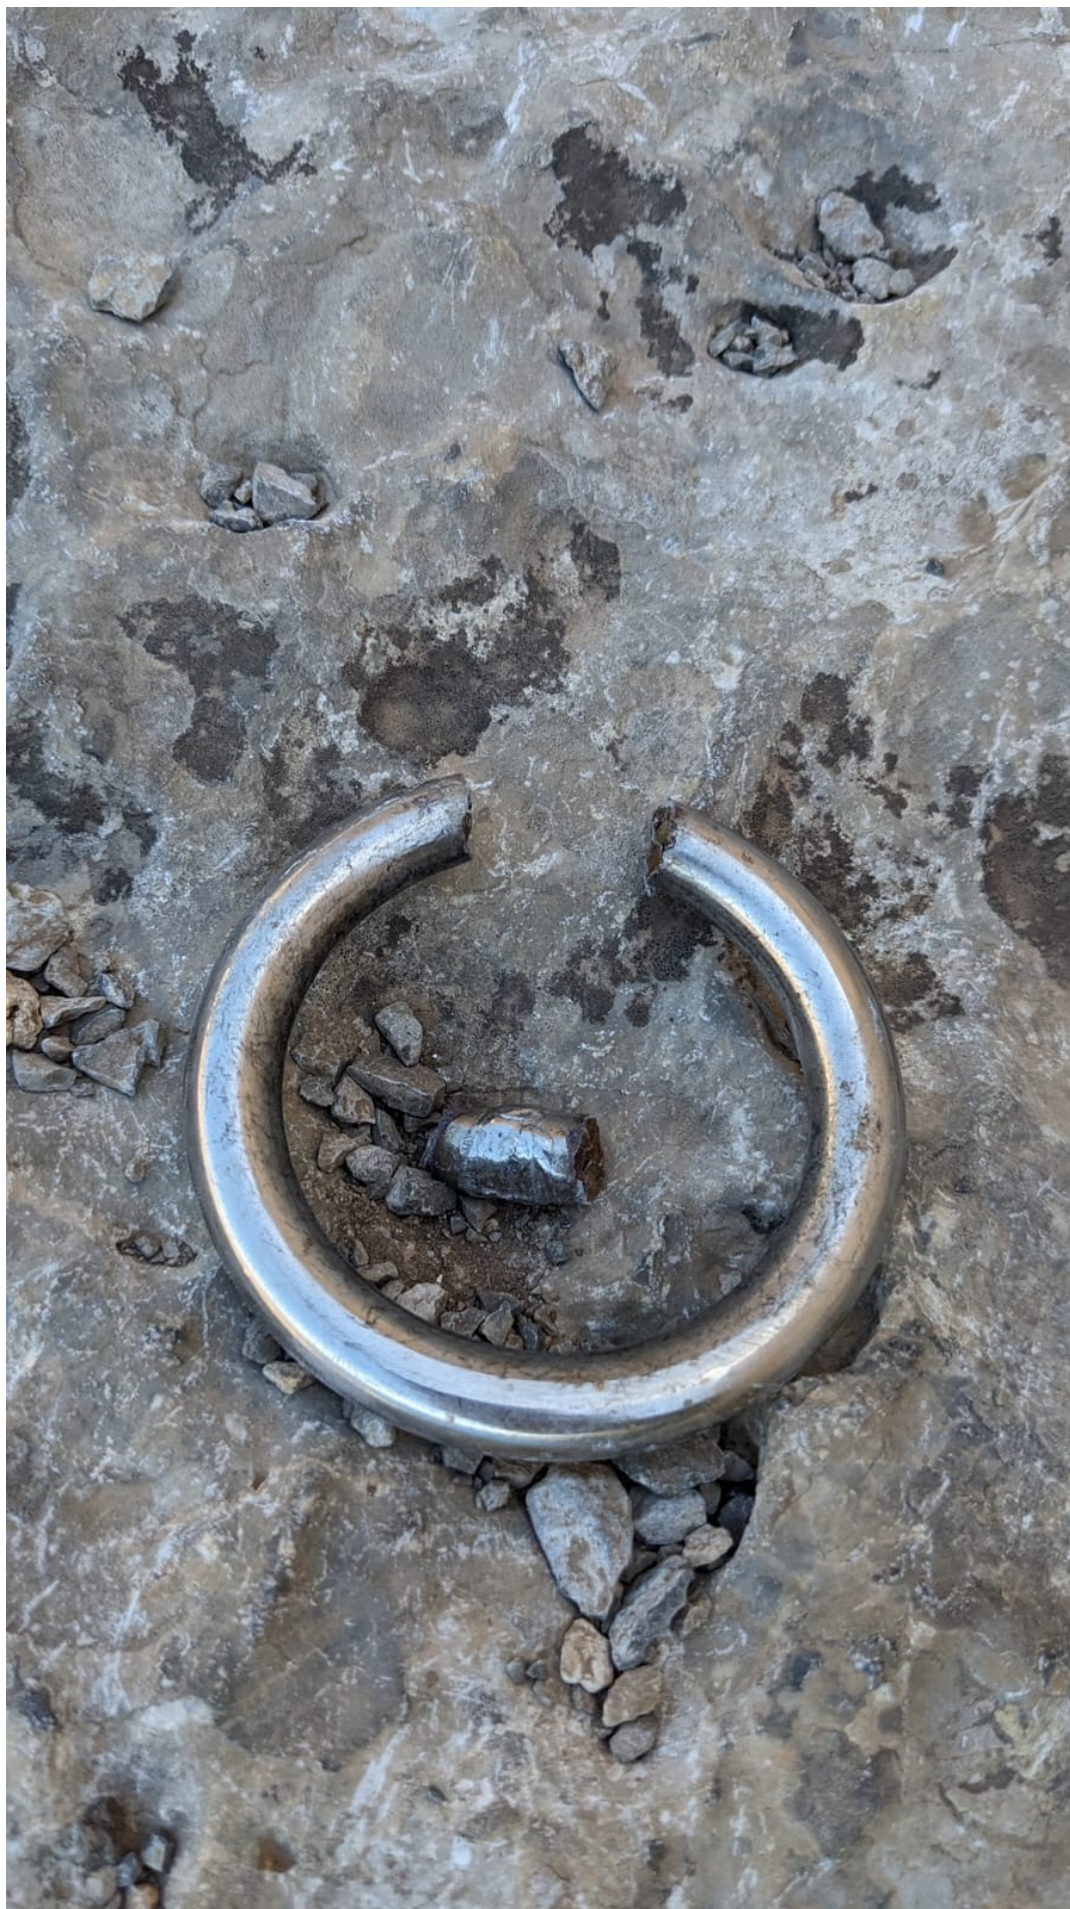
S. Equy : Boucle fendue, Kalymnos, Grèce
